Villa “La Saracena”

Project architect: Luigi Moretti (Roma 1907 - Isola di Capraia 1973)

Renovation: 2016 - 2020

Architect: Architect Paolo Verdeschi, with architect Flavio Fiorucci, architect Giulio Valerio Mancini, architect Giulia Seppiacci.

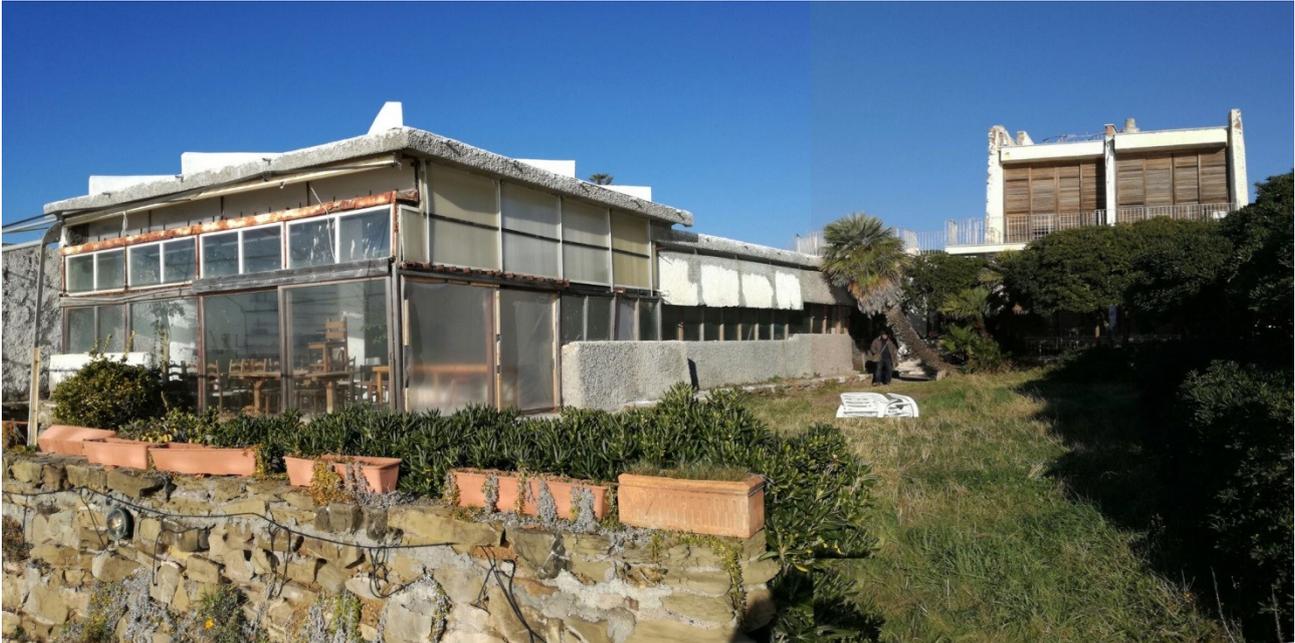
Condition of the villa before the restoration in 2016.

- External plasters detached (chemical analysis, study of the implementation technique, cleaning, reinforcement of the detached parts, reinstallation of missing parts with the same materials);
- External fixtures, windows and shutters (analysis of the state of disrepair, cleaning, restoration - where possible - of the rotten parts with the wood retrieved from the living room windows, painting. Cleaning of the metalware (handles, joints, locks);
- Reinforcement of the internal flooring (detachment of the screed from slab);
- Restoration of the kitchen furniture;

- Replacement of the entire bearing structure of the windows and of the living room sun-shading panel ("*veletta*") and gallery;
- Restoration of the sun-shading panel ("*veletta*") according to the original project;
- Restoration of all the living room windows according to the original project.

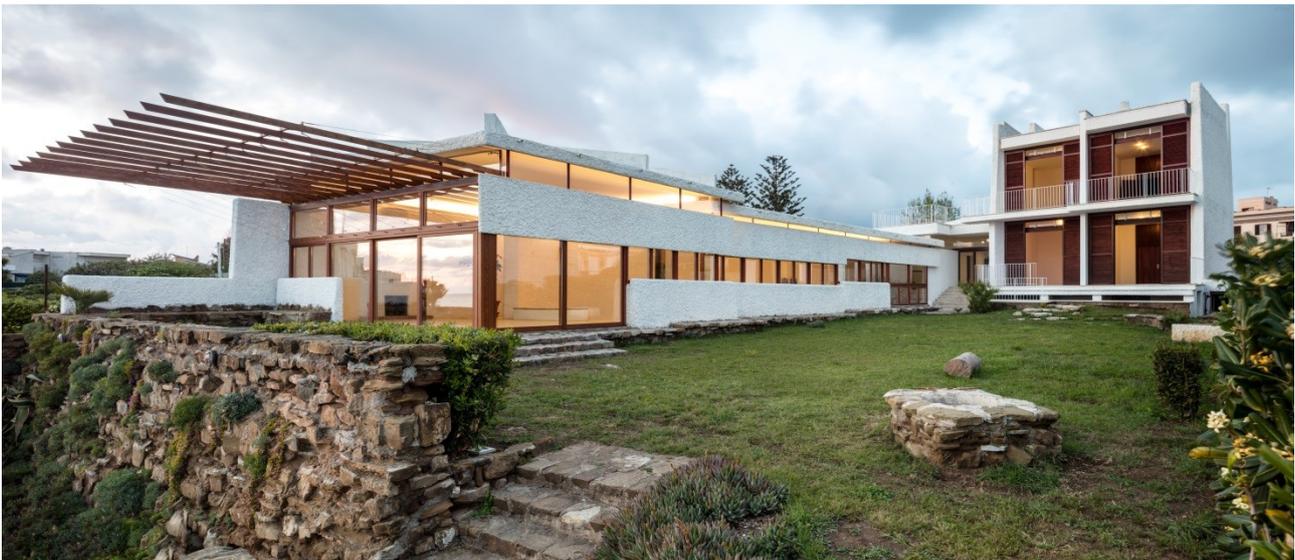
Condition of the villa after the restoration in 2020.
